Lower Passaic River Restoration Project

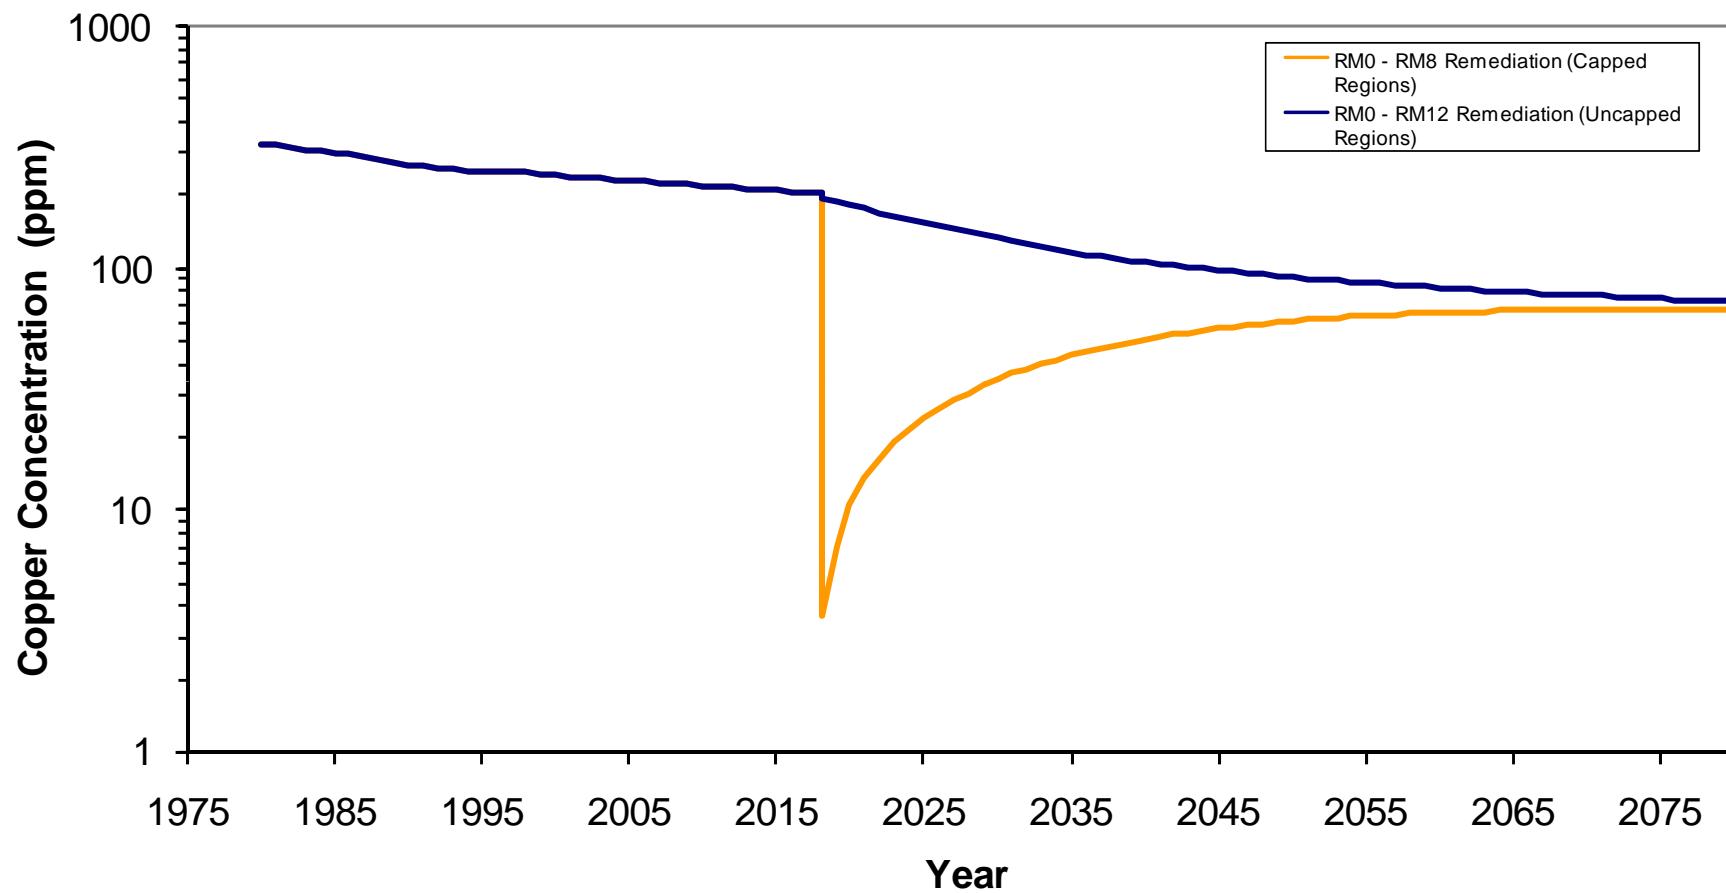
Figure 20-53

Copper
Comparison of Estimated Trajectories in Capped and Uncapped Regions for 0-
6 inch Biologically Active Layer after Capping and Dredging RM0 - RM8
Lower Passaic River Restoration Project

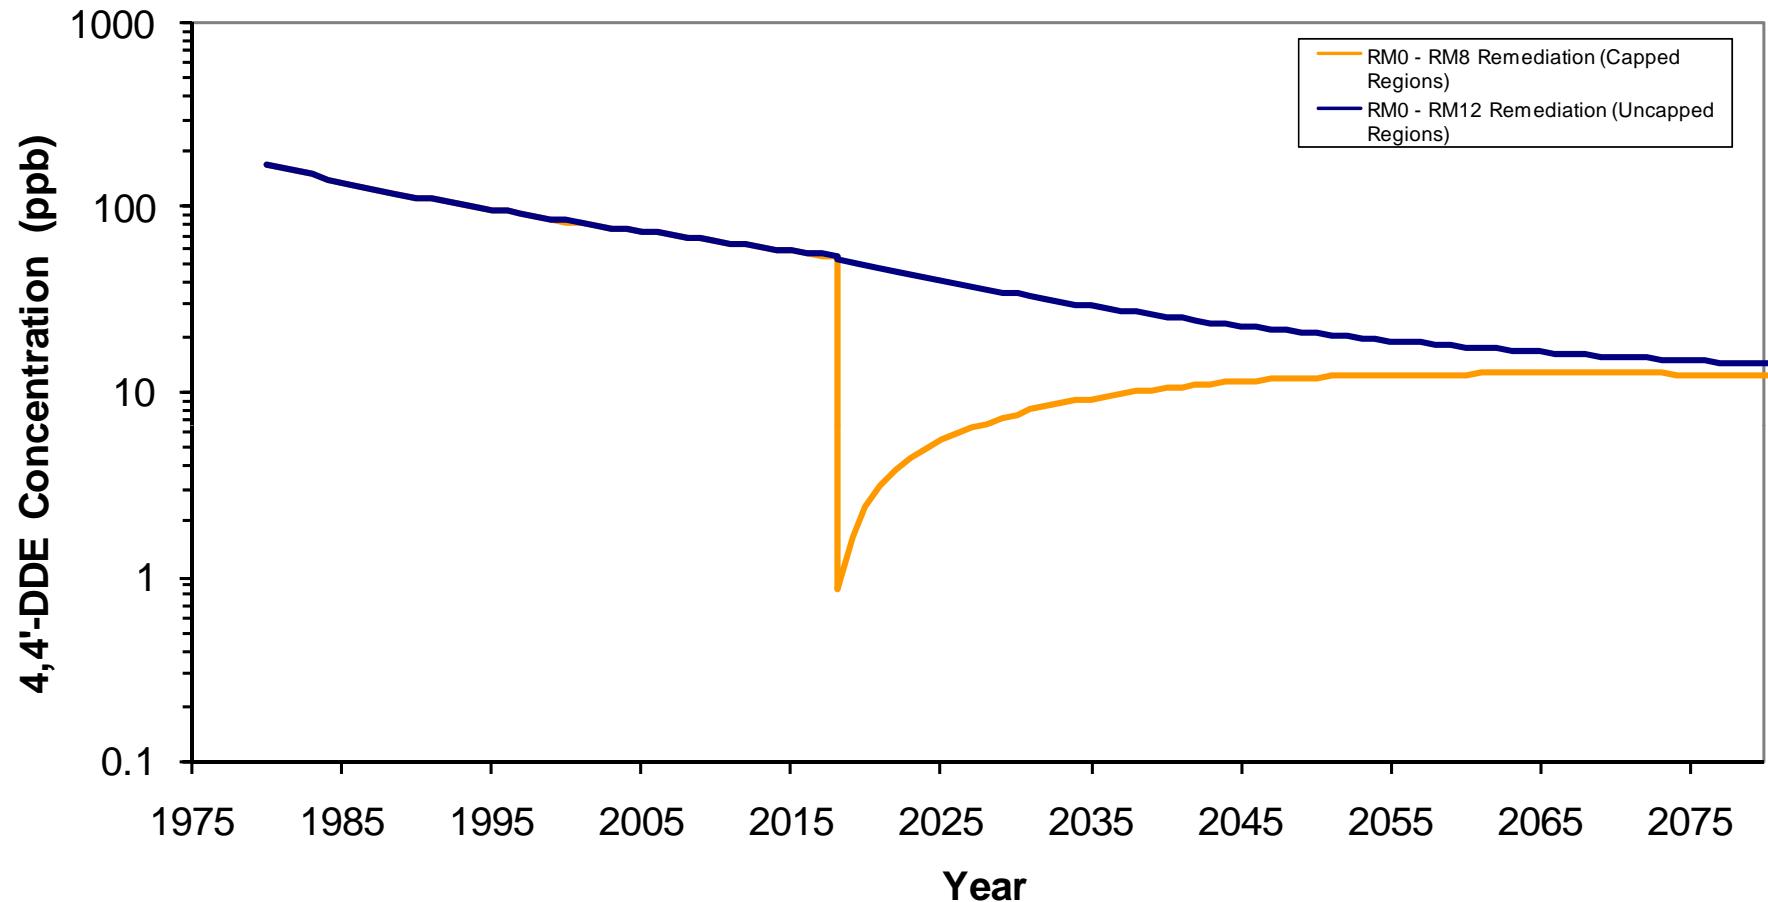
Figure 20-54

4,4'-DDE
Comparison of Estimated Trajectories in Capped and Uncapped Regions for 0-
6 inch Biologically Active Layer after Capping and Dredging RM0 - RM8
Lower Passaic River Restoration Project

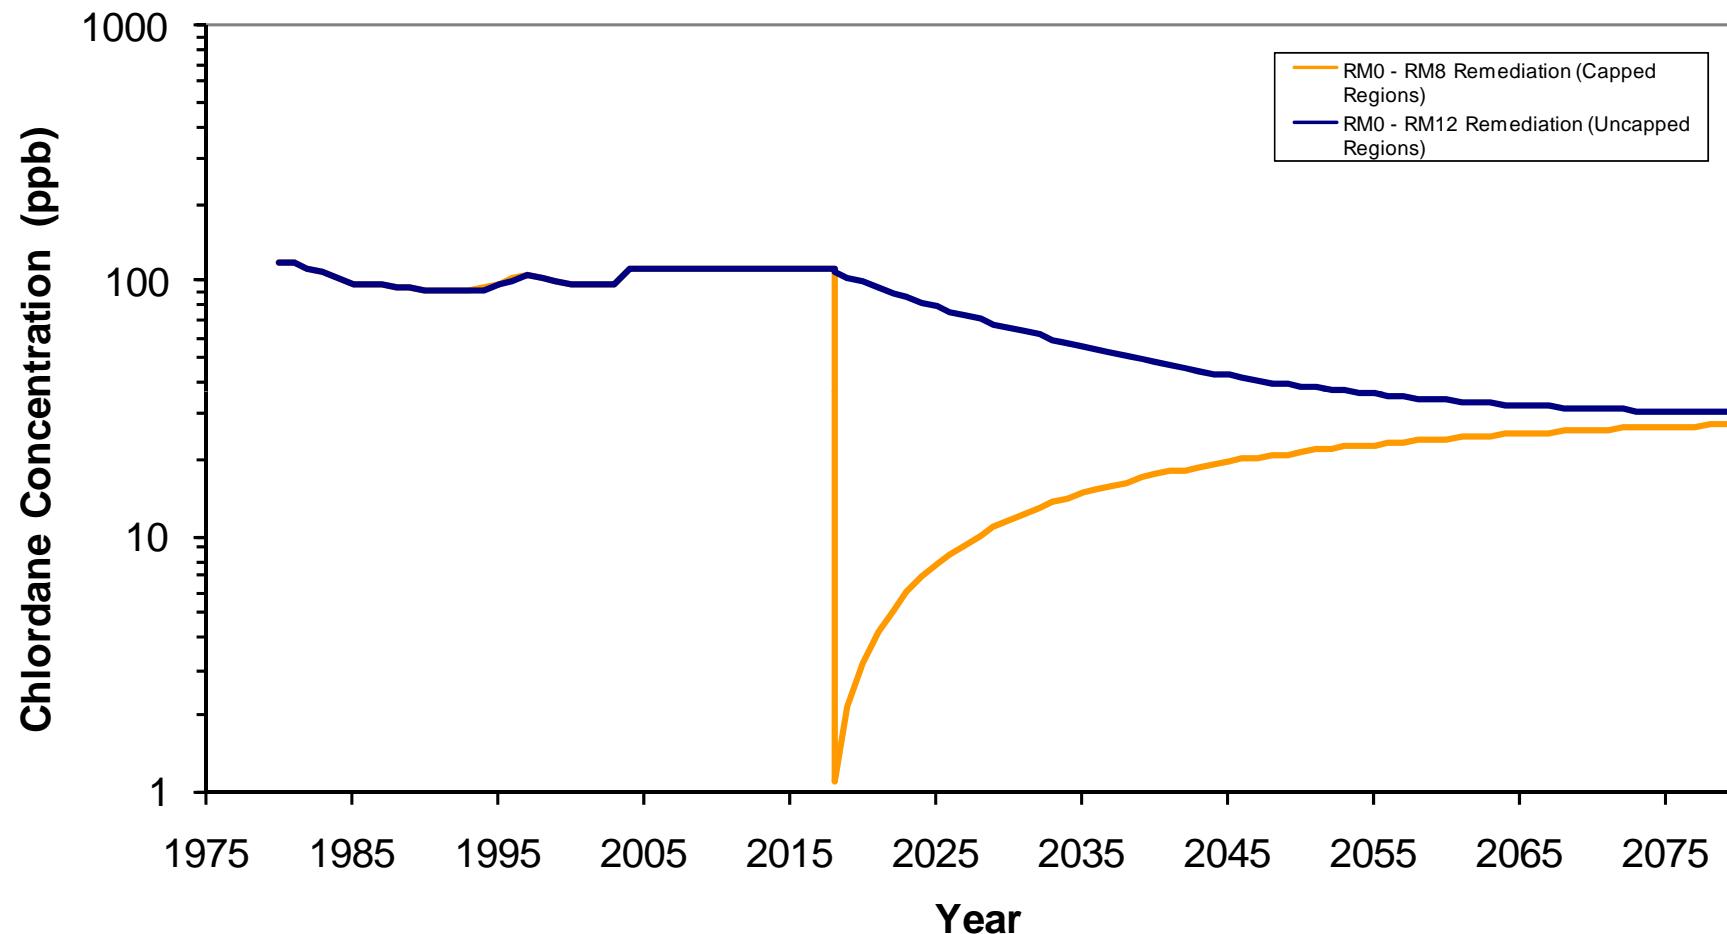
Figure 20-55

Chlordane
Comparison of Estimated Trajectories in Capped and Uncapped Regions for 0-
6 inch Biologically Active Layer after Capping and Dredging RM0 - RM8
Lower Passaic River Restoration Project

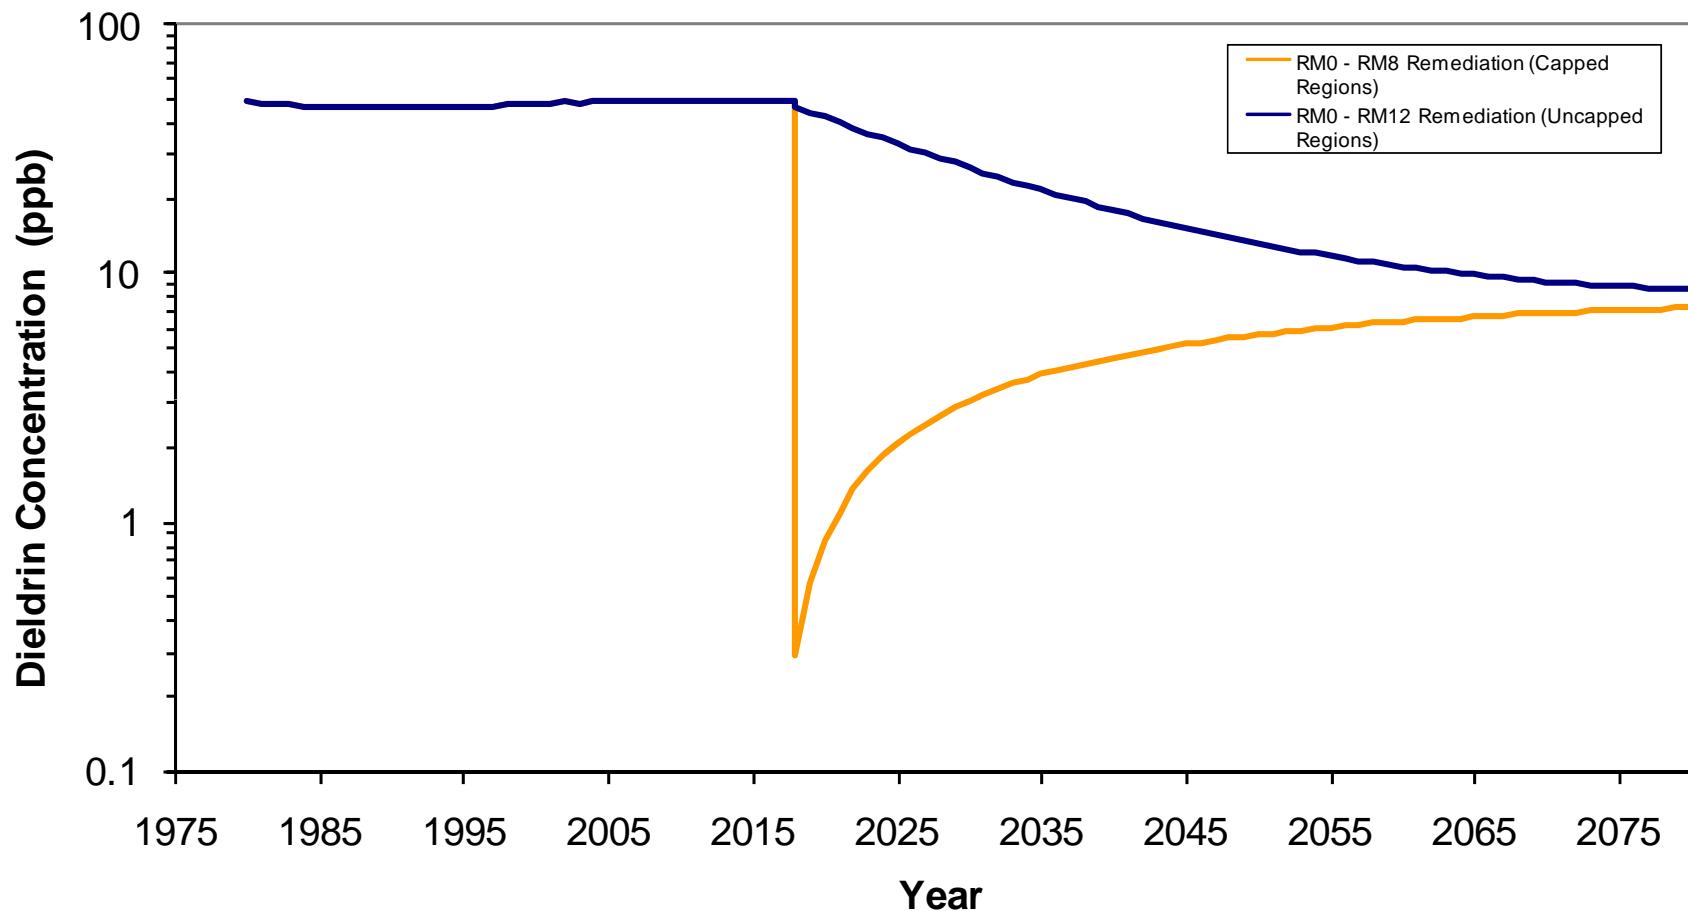
Figure 20-56

Dieldrin
Comparison of Estimated Trajectories in Capped and Uncapped Regions for 0-
6 inch Biologically Active Layer after Capping and Dredging RM0 - RM8
Lower Passaic River Restoration Project

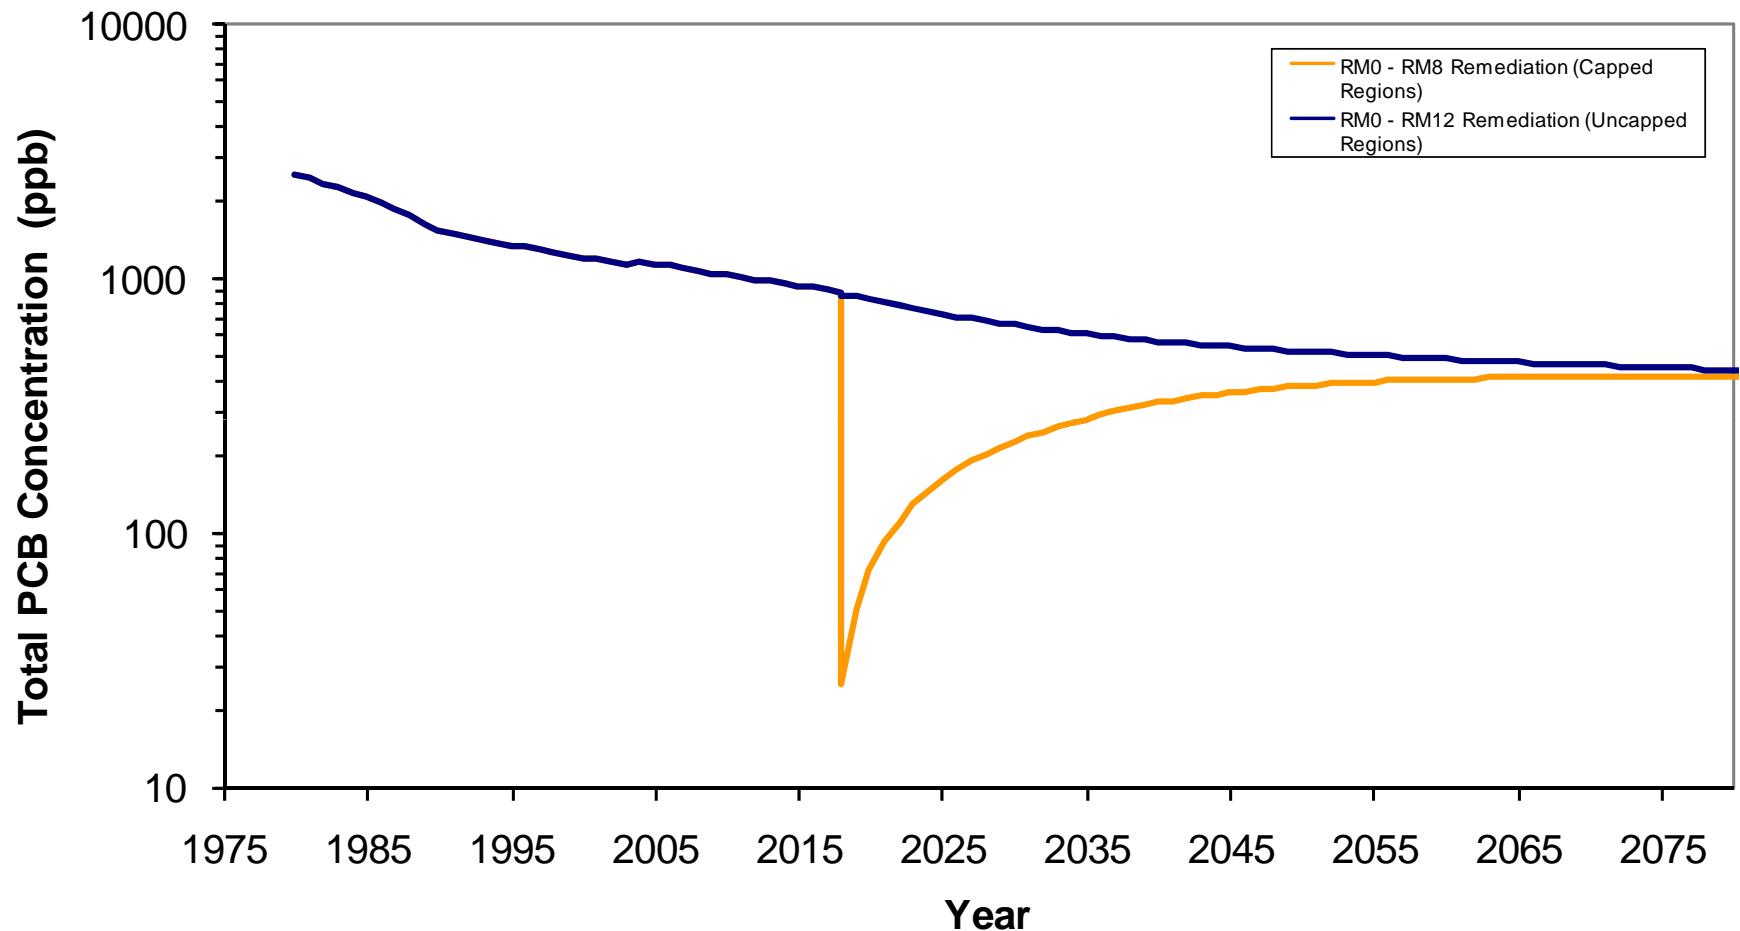
Figure 20-57

Total PCB
Comparison of Estimated Trajectories for Remediation Options for 0-6 inch
Biologically Active Layer in Capped Regions
Lower Passaic River Restoration Project

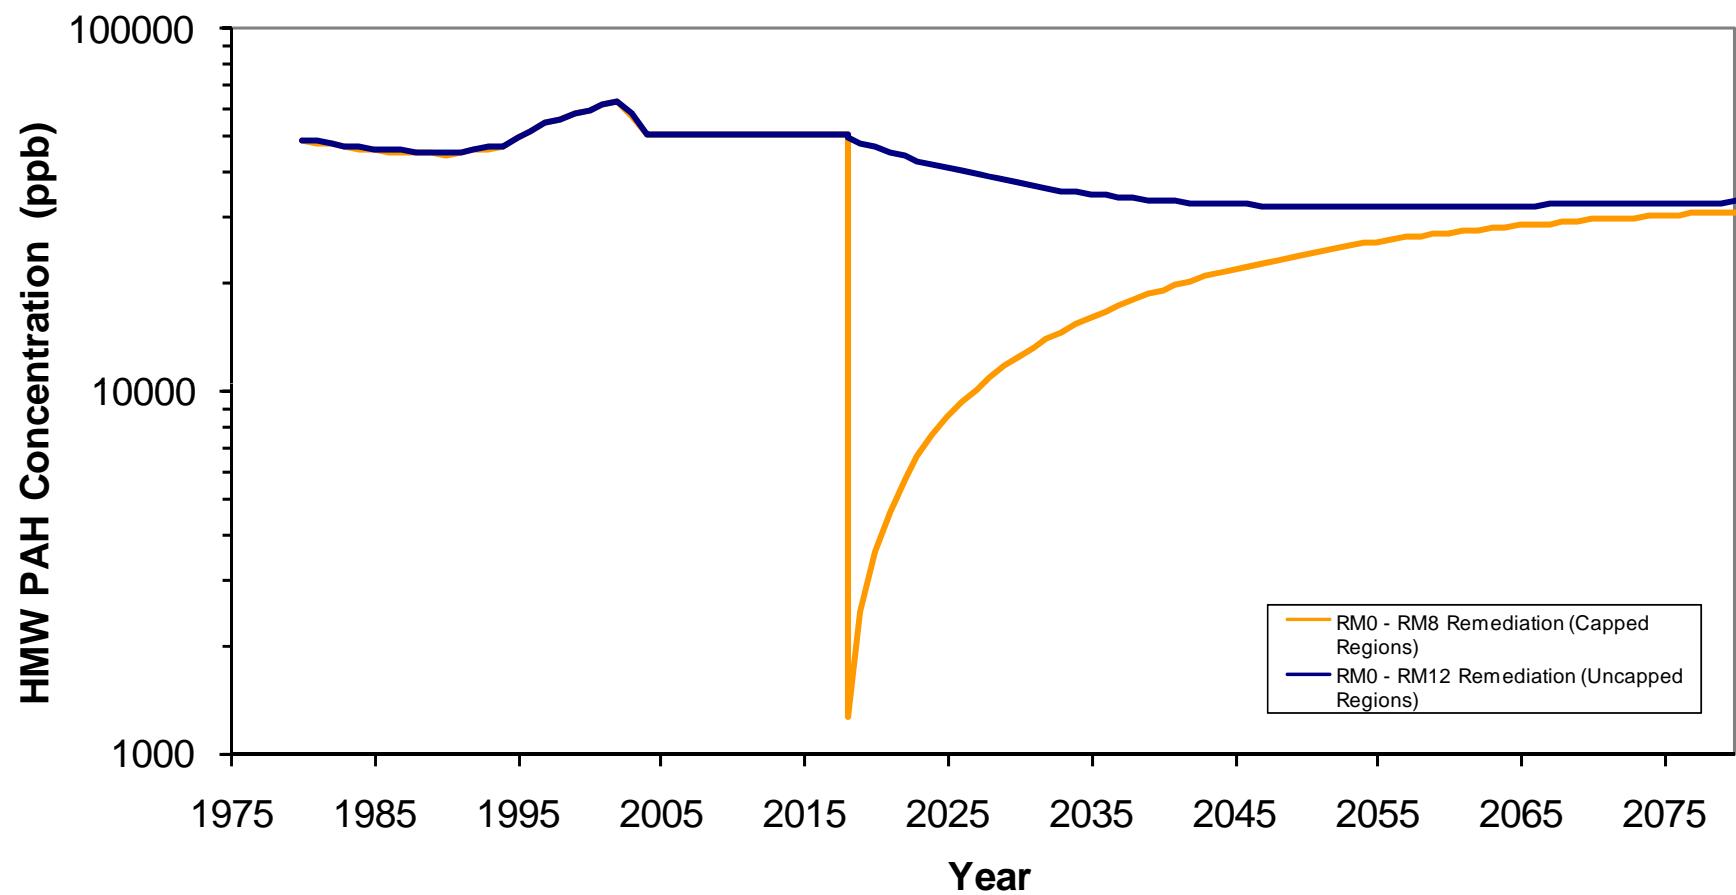
Figure 20-58

HMW PAH
Comparison of Estimated Trajectories in Capped and Uncapped Regions for 0-
6 inch Biologically Active Layer after Capping and Dredging RM0 - RM8
Lower Passaic River Restoration Project

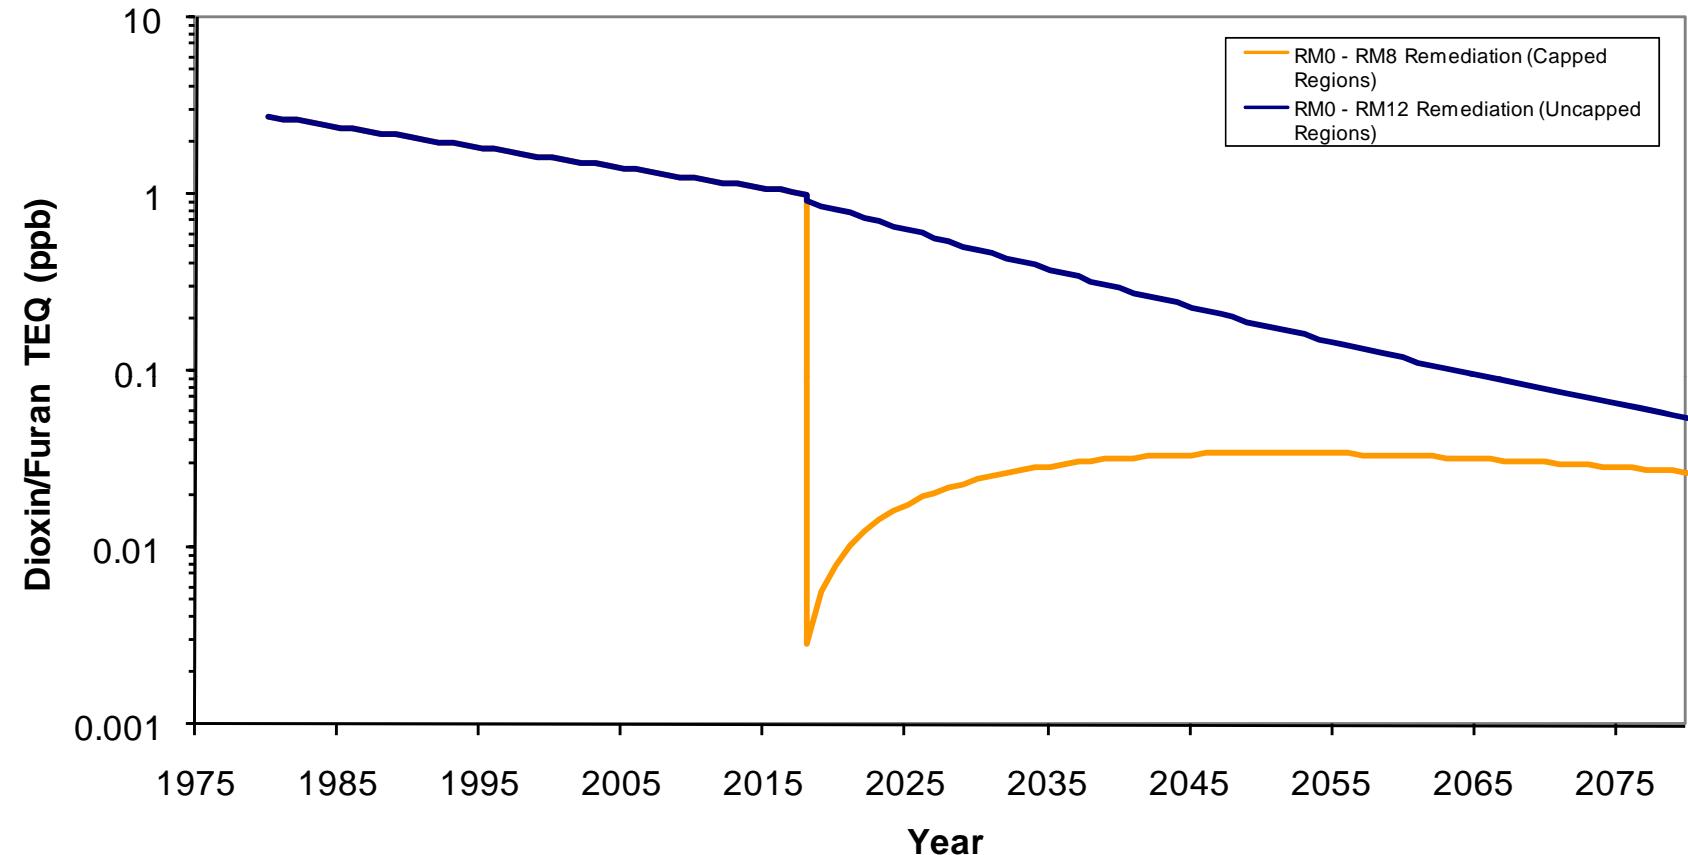
Figure 20-59

Dioxin/Furan TEQ (Fish)
Comparison of Estimated Trajectories in Capped and Uncapped Regions for 0-
6 inch Biologically Active Layer after Capping and Dredging RM0 - RM8
Lower Passaic River Restoration Project

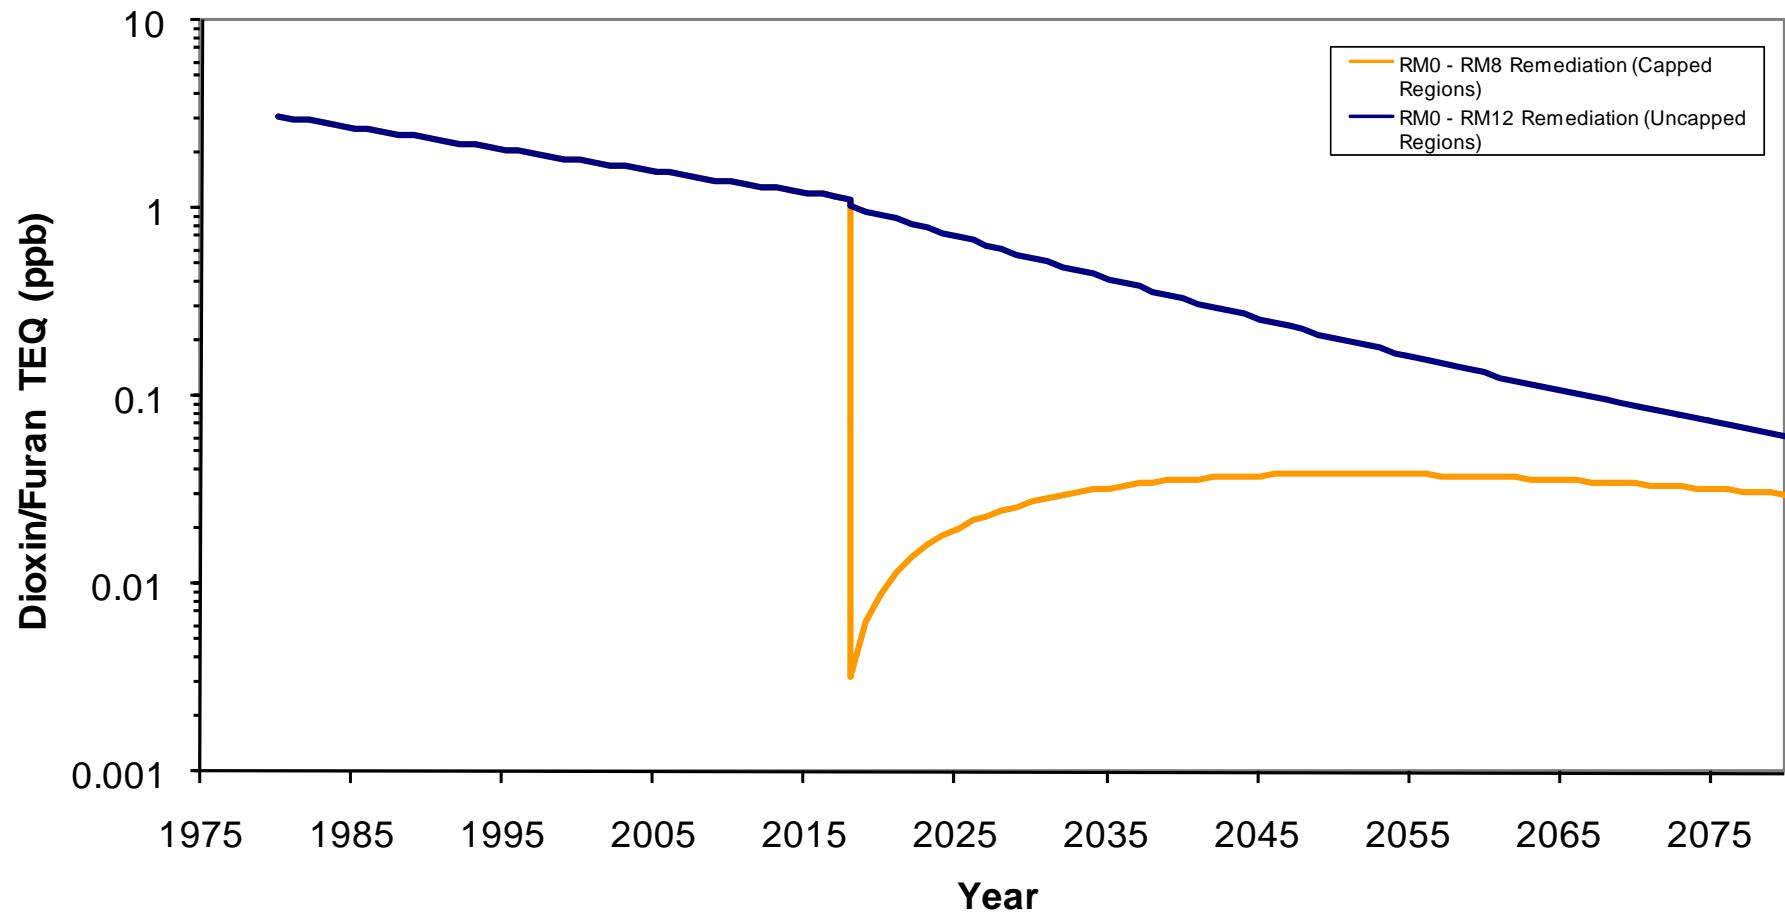
Figure 20-60

Dioxin/Furan TEQ (Bird)
Comparison of Estimated Trajectories in Capped and Uncapped Regions for 0-
6 inch Biologically Active Layer after Capping and Dredging RM0 - RM8
Lower Passaic River Restoration Project

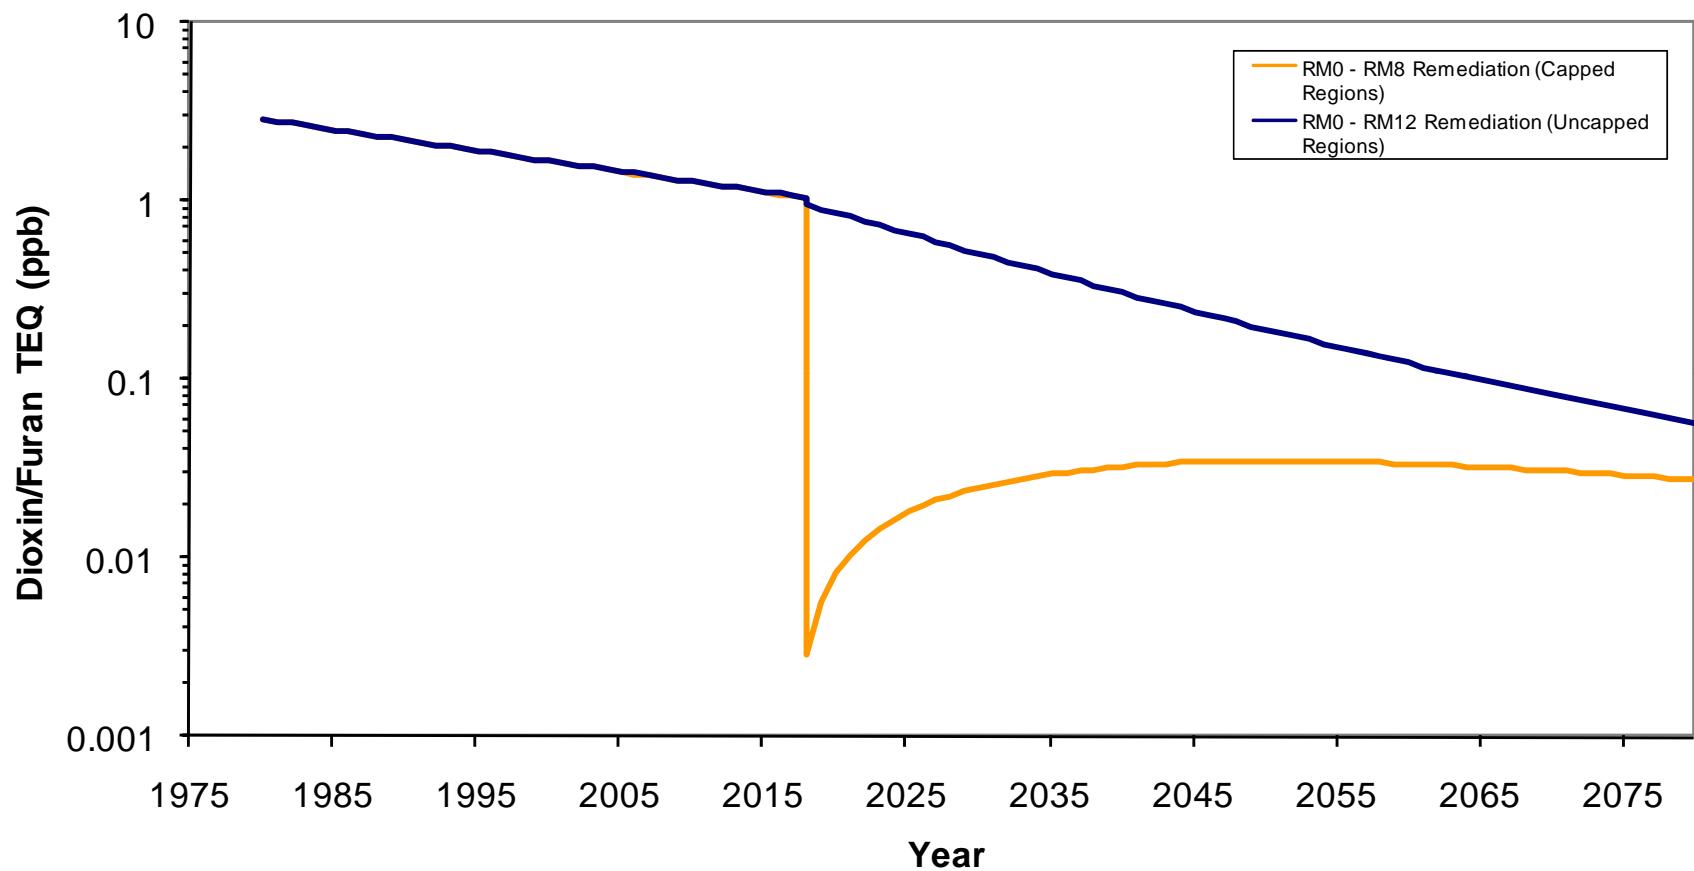
Figure 20-61

Dioxin/Furan TEQ (Mammal)
Comparison of Estimated Trajectories in Capped and Uncapped Regions for 0-6 inch Biologically Active Layer after Capping and Dredging RM0 - RM8
Lower Passaic River Restoration Project

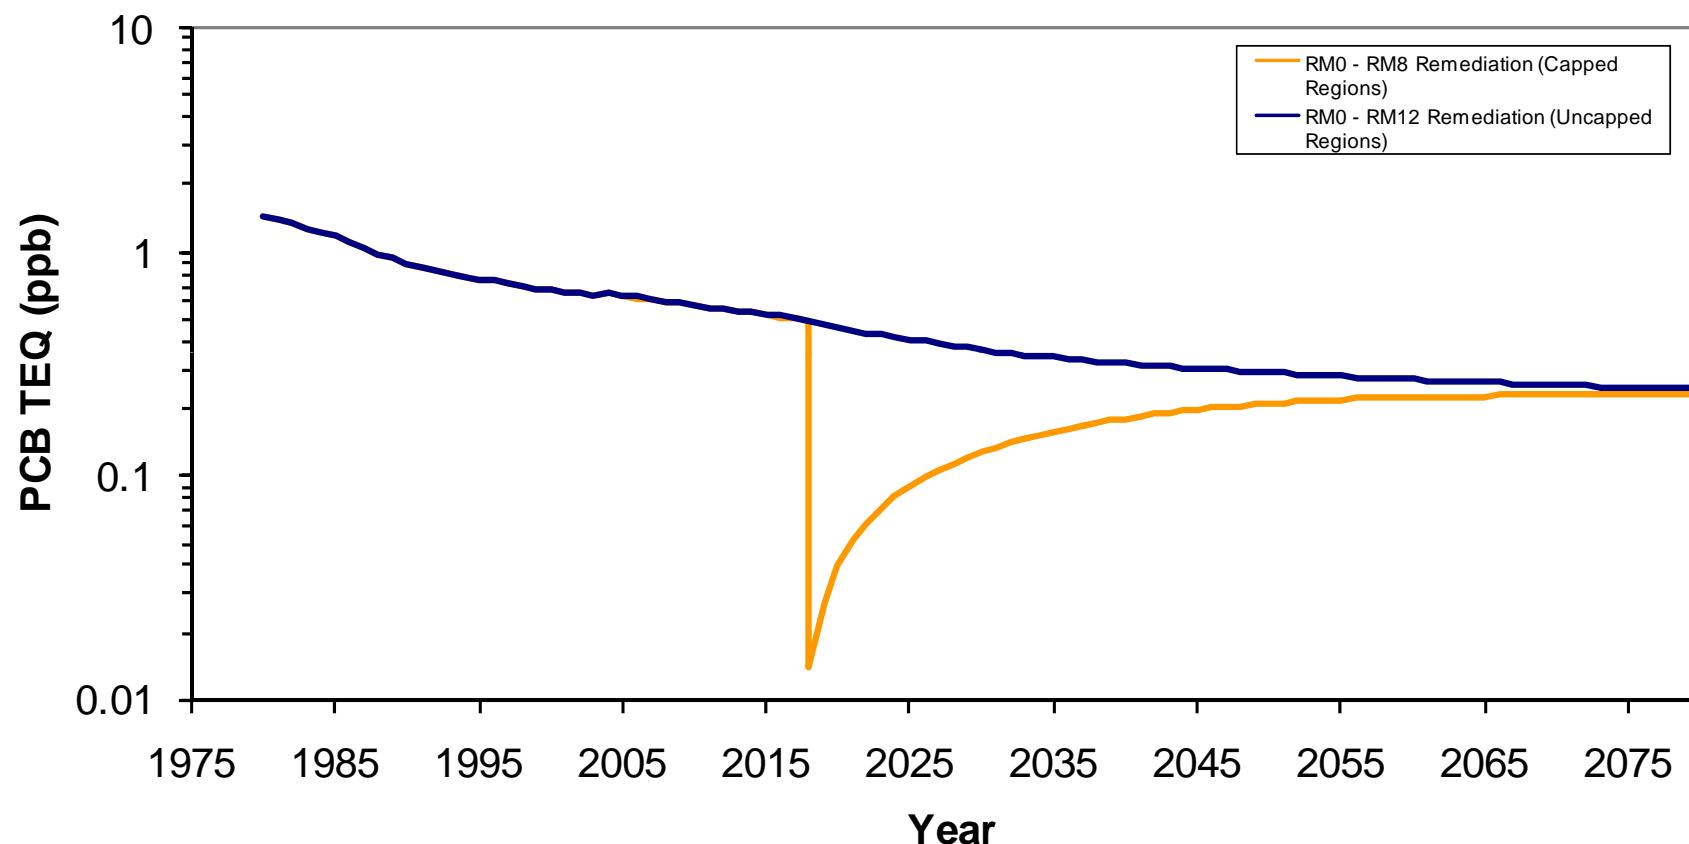
Figure 20-62

PCB TEQ (Fish)
Comparison of Estimated Trajectories in Capped and Uncapped Regions for 0-
6 inch Biologically Active Layer after Capping and Dredging RM0 - RM8
Lower Passaic River Restoration Project

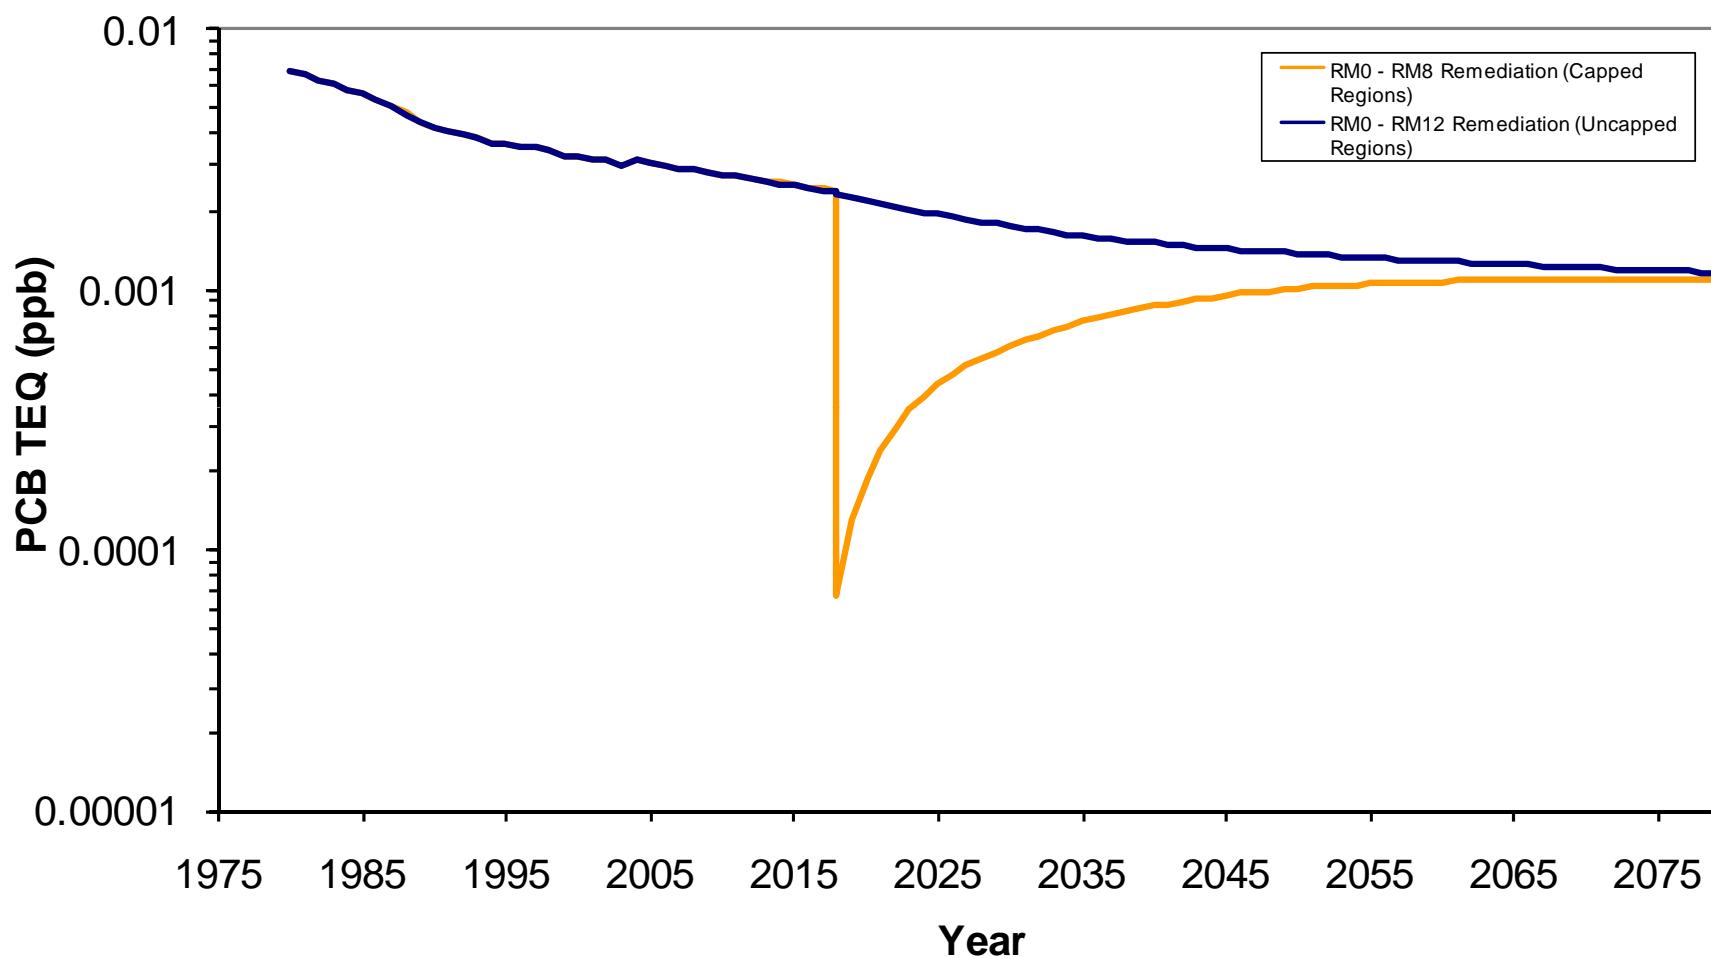
Figure 20-63

PCB TEQ (Bird)
Comparison of Estimated Trajectories in Capped and Uncapped Regions for 0-
6 inch Biologically Active Layer after Capping and Dredging RM0 - RM8
Lower Passaic River Restoration Project

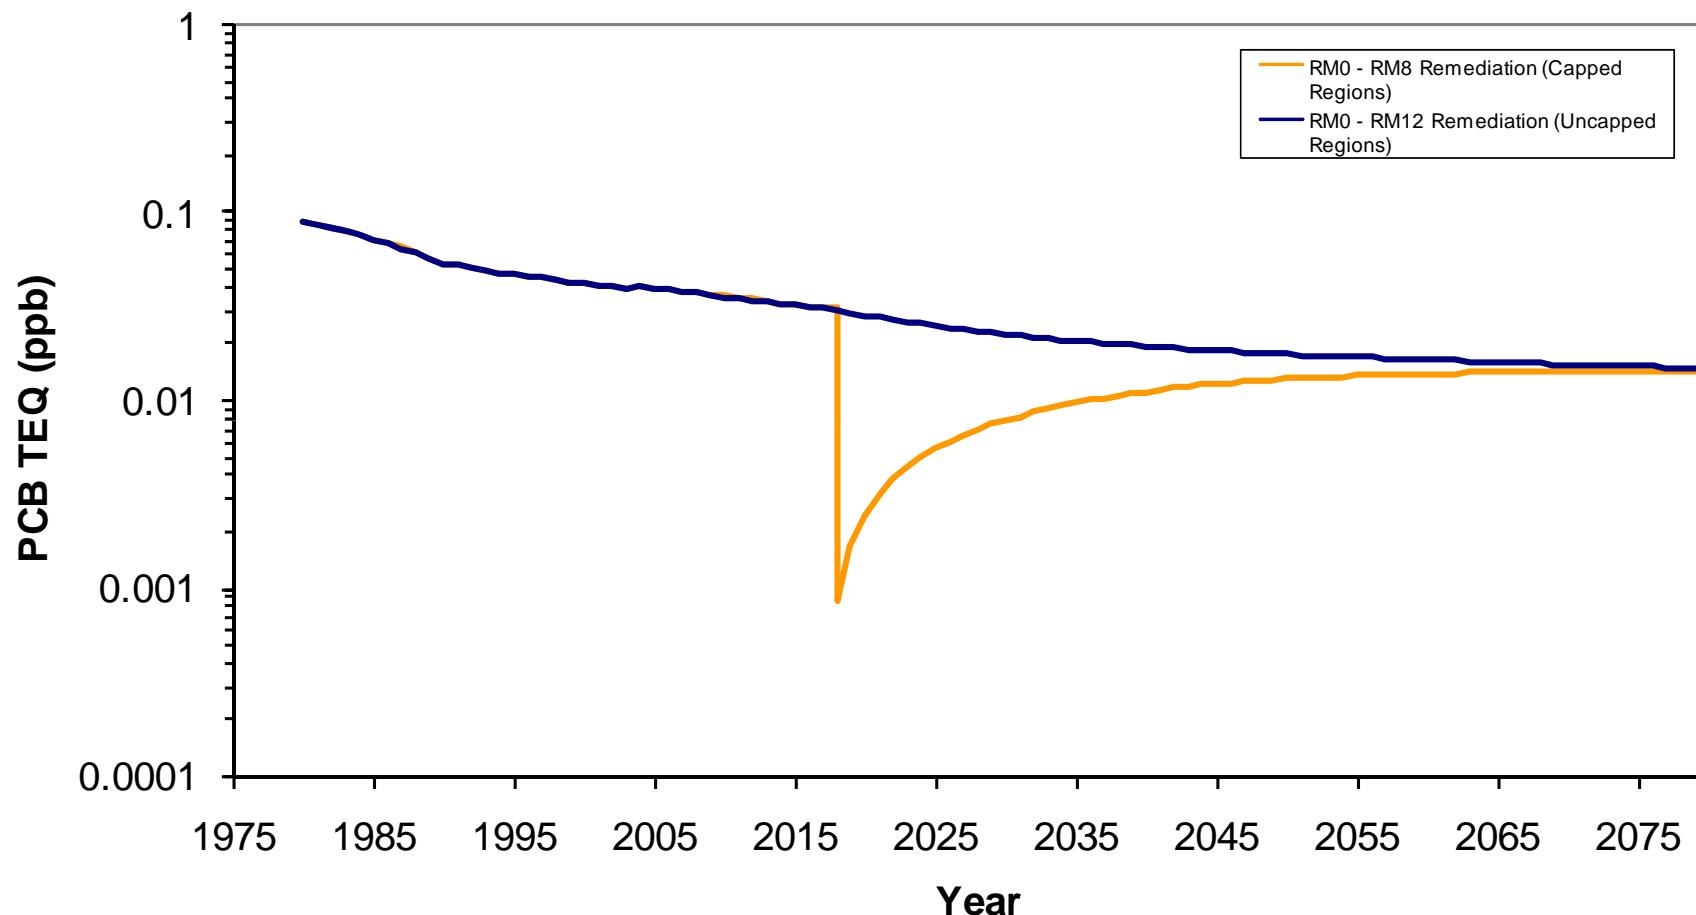
Figure 20-64

PCB TEQ (Mammal)
Comparison of Estimated Trajectories in Capped and Uncapped Regions for 0-
6 inch Biologically Active Layer after Capping and Dredging RM0 - RM8
Lower Passaic River Restoration Project
